KIRKSIDE INN

SITE RESOURCES ANALYSIS

The purpose of this Site Resources Analysis is to compile a holistic understanding of existing conditions of the environment encompassing Kirkside Inn to inform the design team’s schematic layout and program. Evaluating the physical environmental conditions before finalizing the site design will enable the most contextually appropriate schemes to present themselves, as well as represent the Earth as a project stakeholder as we become aware of potential short- and long-term implications of new activity on the site.

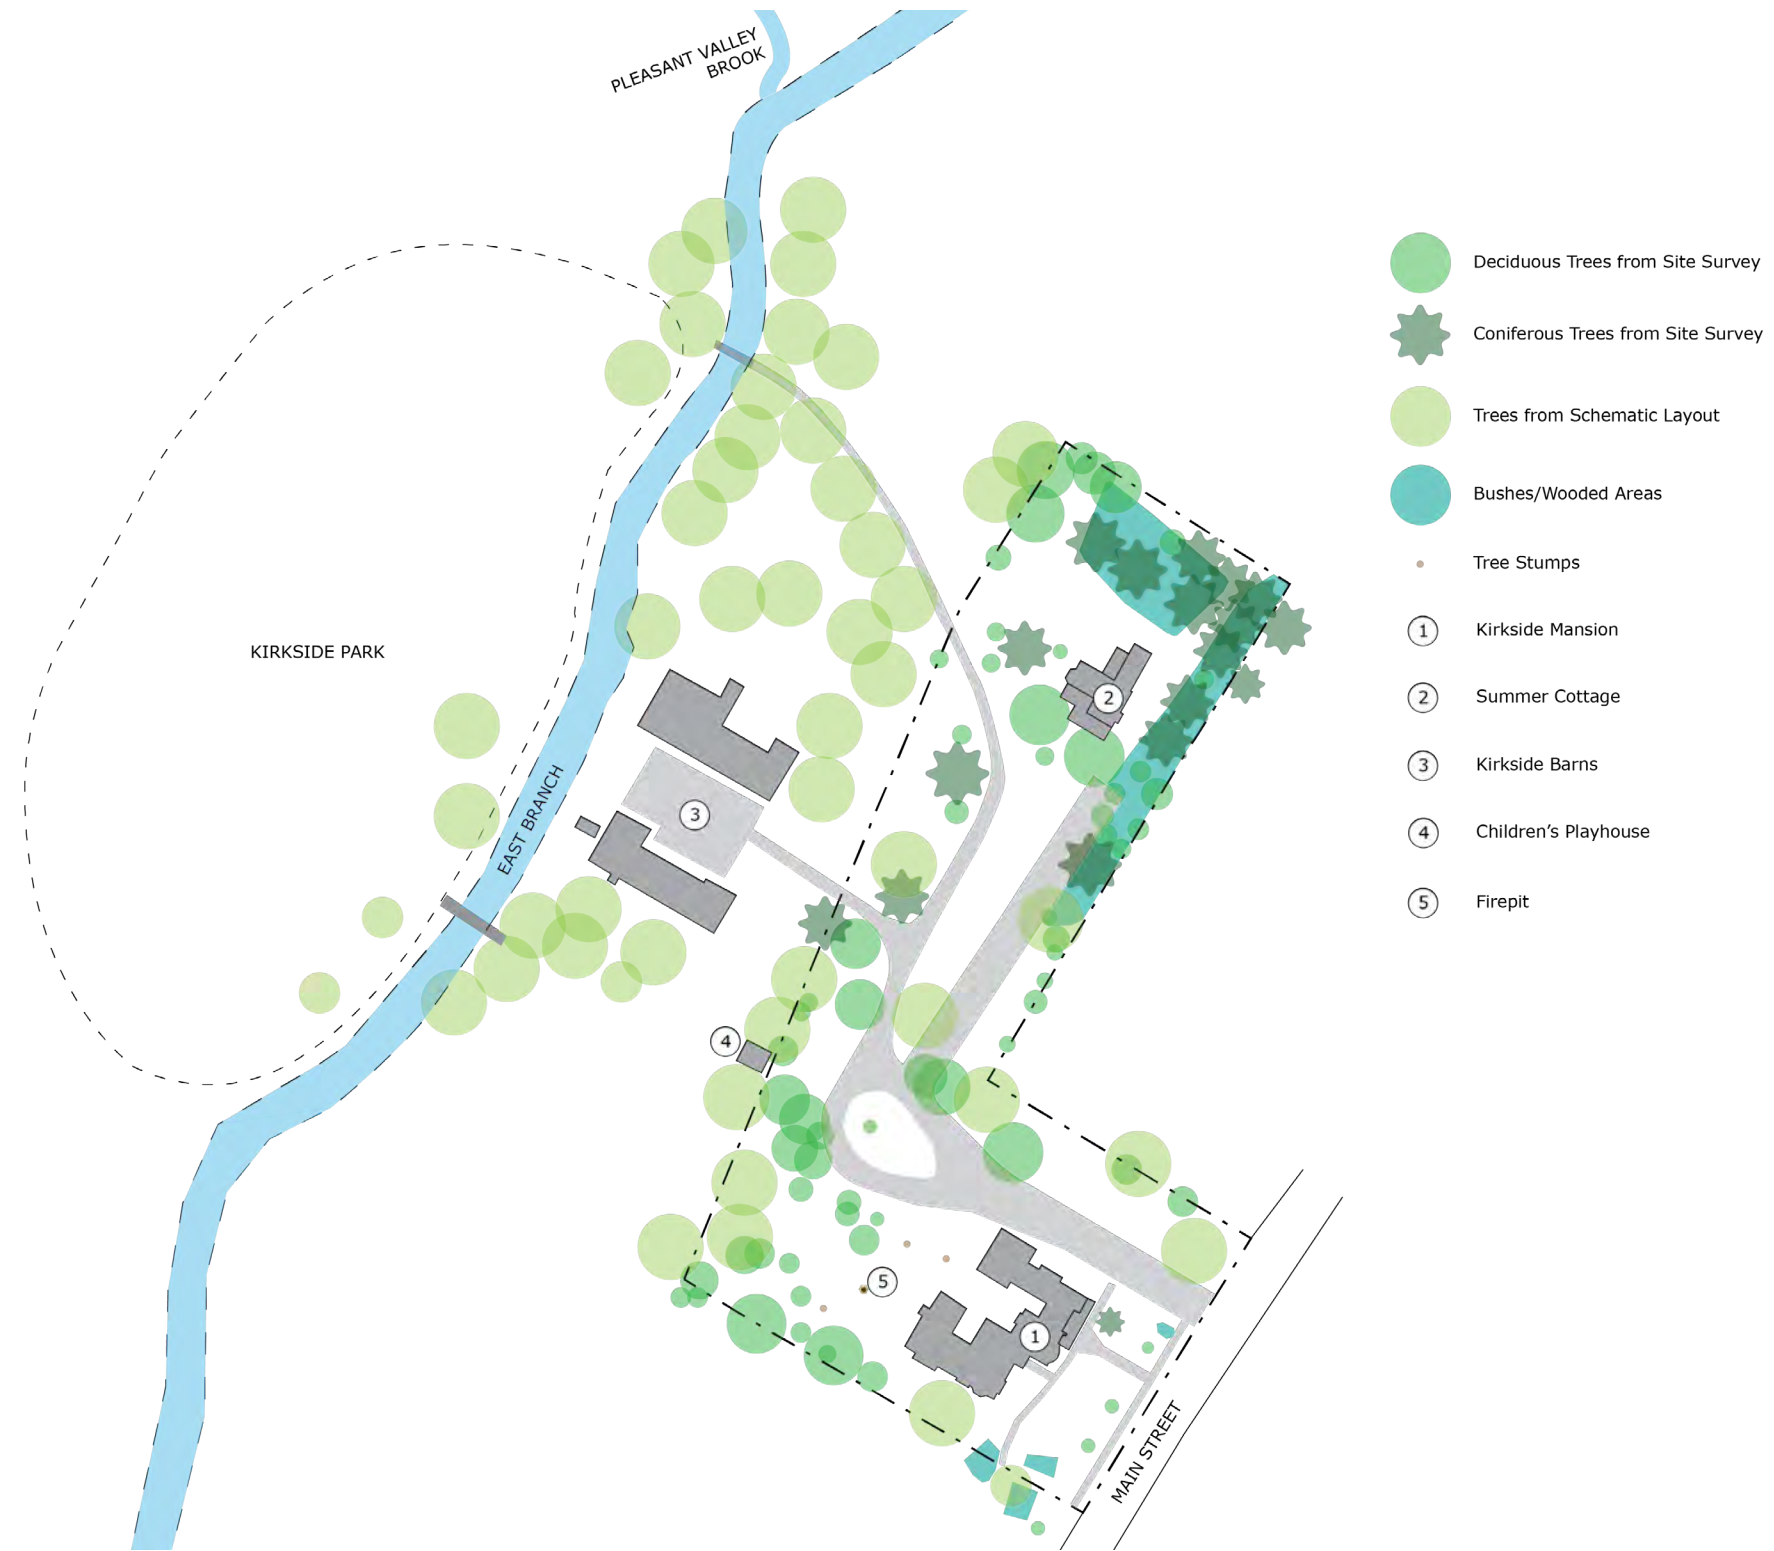
The grounds of Kirkside occupy approximately 2.65 acres

The grounds of Kirkside Park, including the barns, occupy approximately 12 acres

The East Branch of the Delaware River runs between the barns and the park, and is about 20-35 feet wide in this area

There are two foot bridges crossing the river at the north and south ends of the park

The site is relatively wooded, with a mix of coniferous spruce trees and deciduous maples, with two apple and one cherry tree

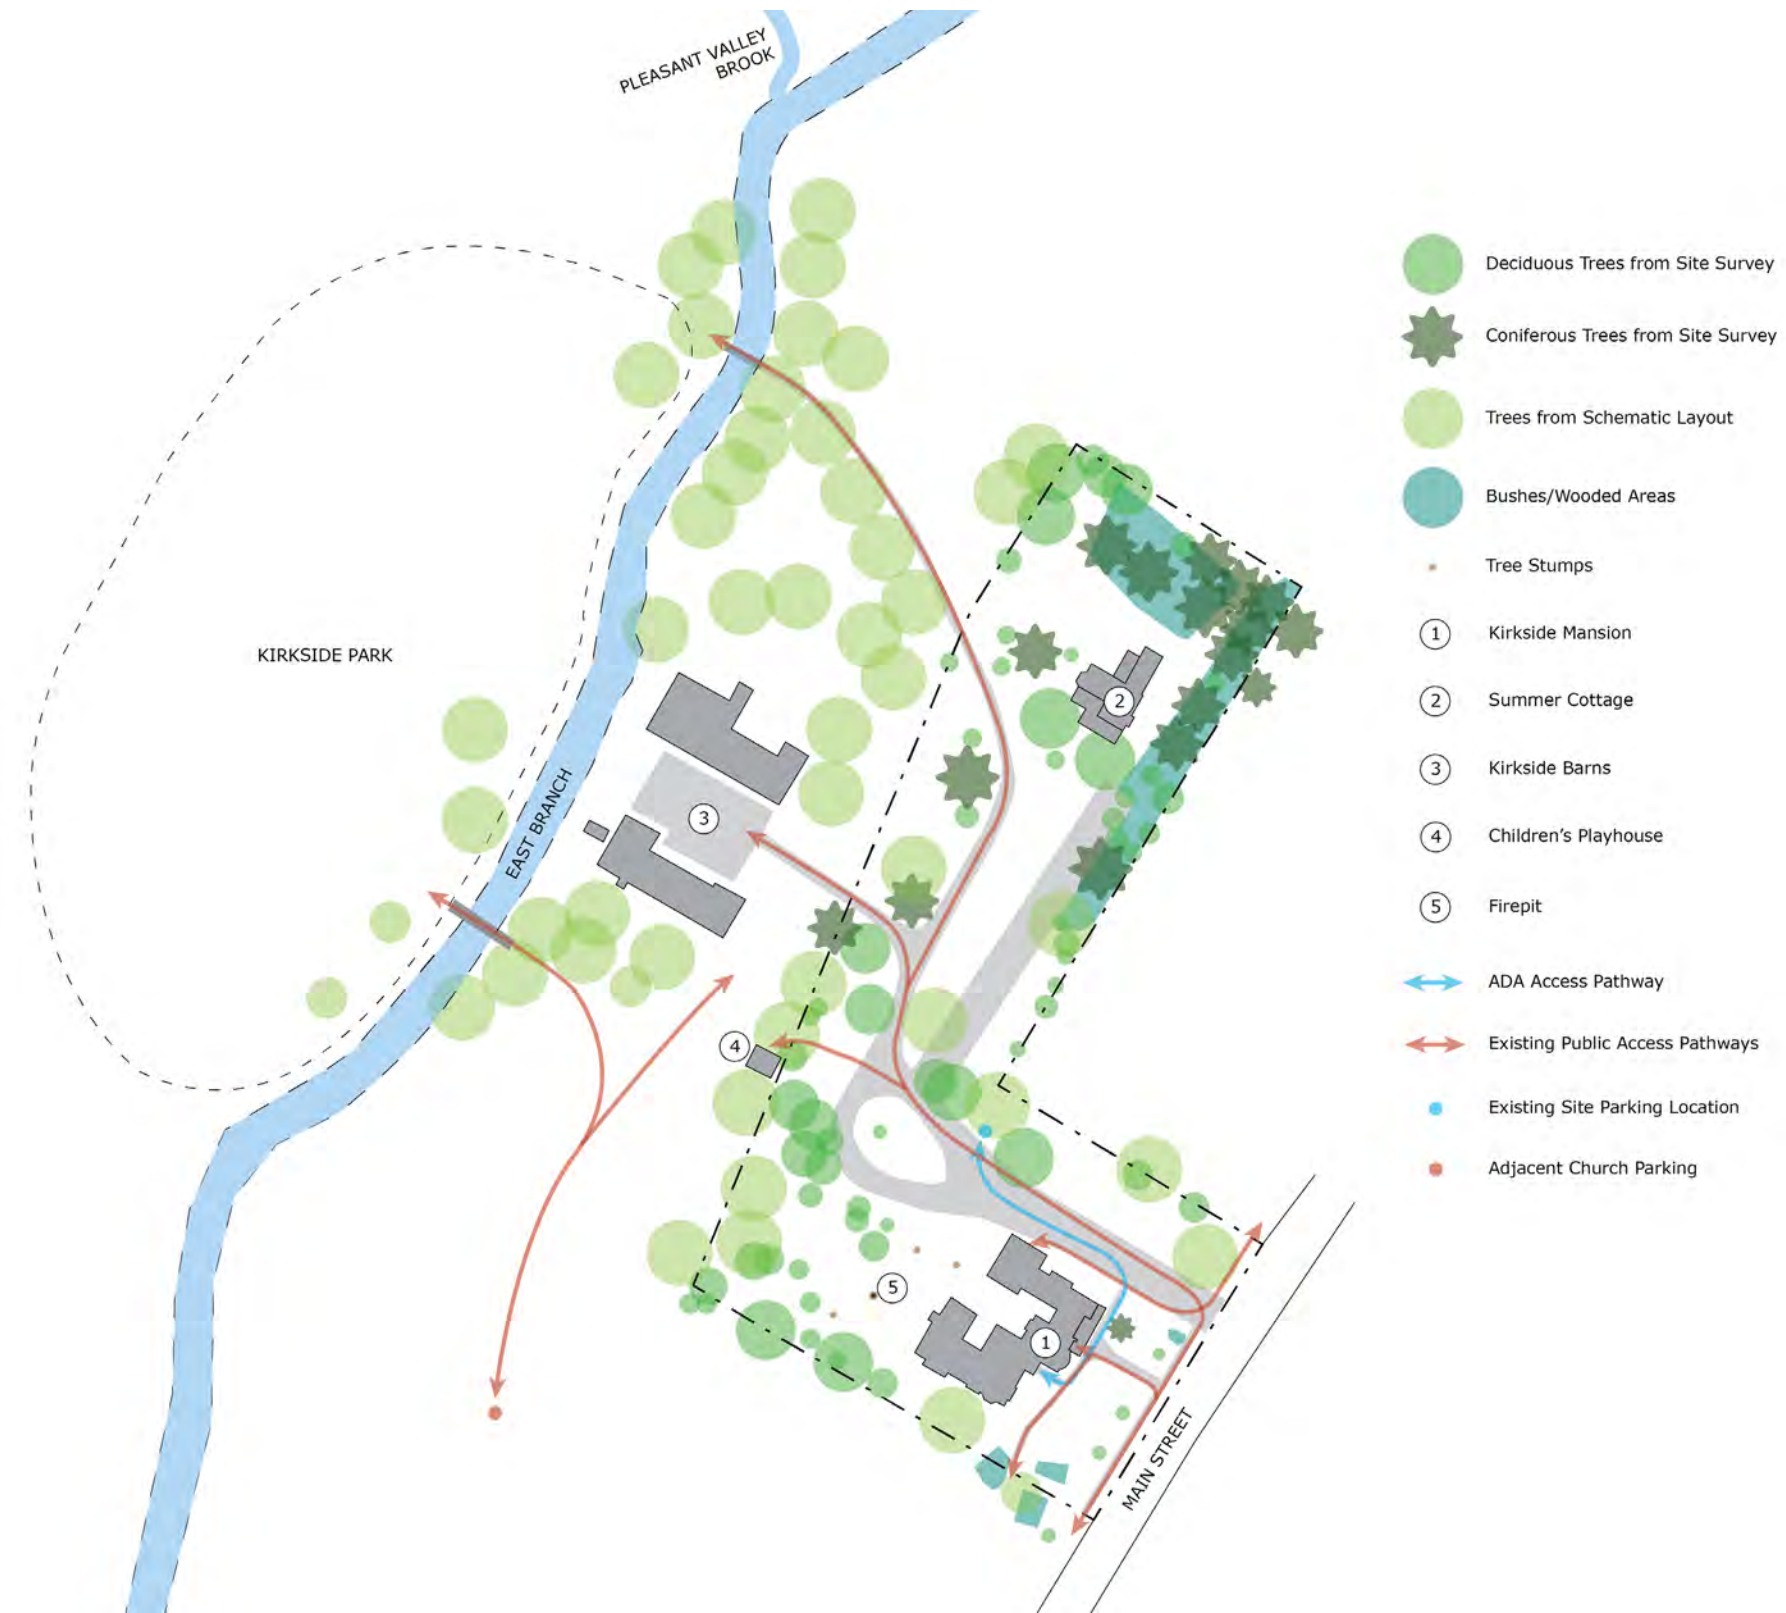
community access

The community currently accesses the public Kirkside Park and event barn grounds by walking or driving up from Main Street, through the existing driveway onto the site.

There may also be some site access from parking in the Jay Gould Memorial Church parking lot and walking over to the grounds.

This public access way must be maintained in the proposed circulation flows for the new site design. Consider how pedestrians may use the driveway/vehicle space to navigate the grounds, and explore options for providing a hybrid people/vehicle right-of-way.

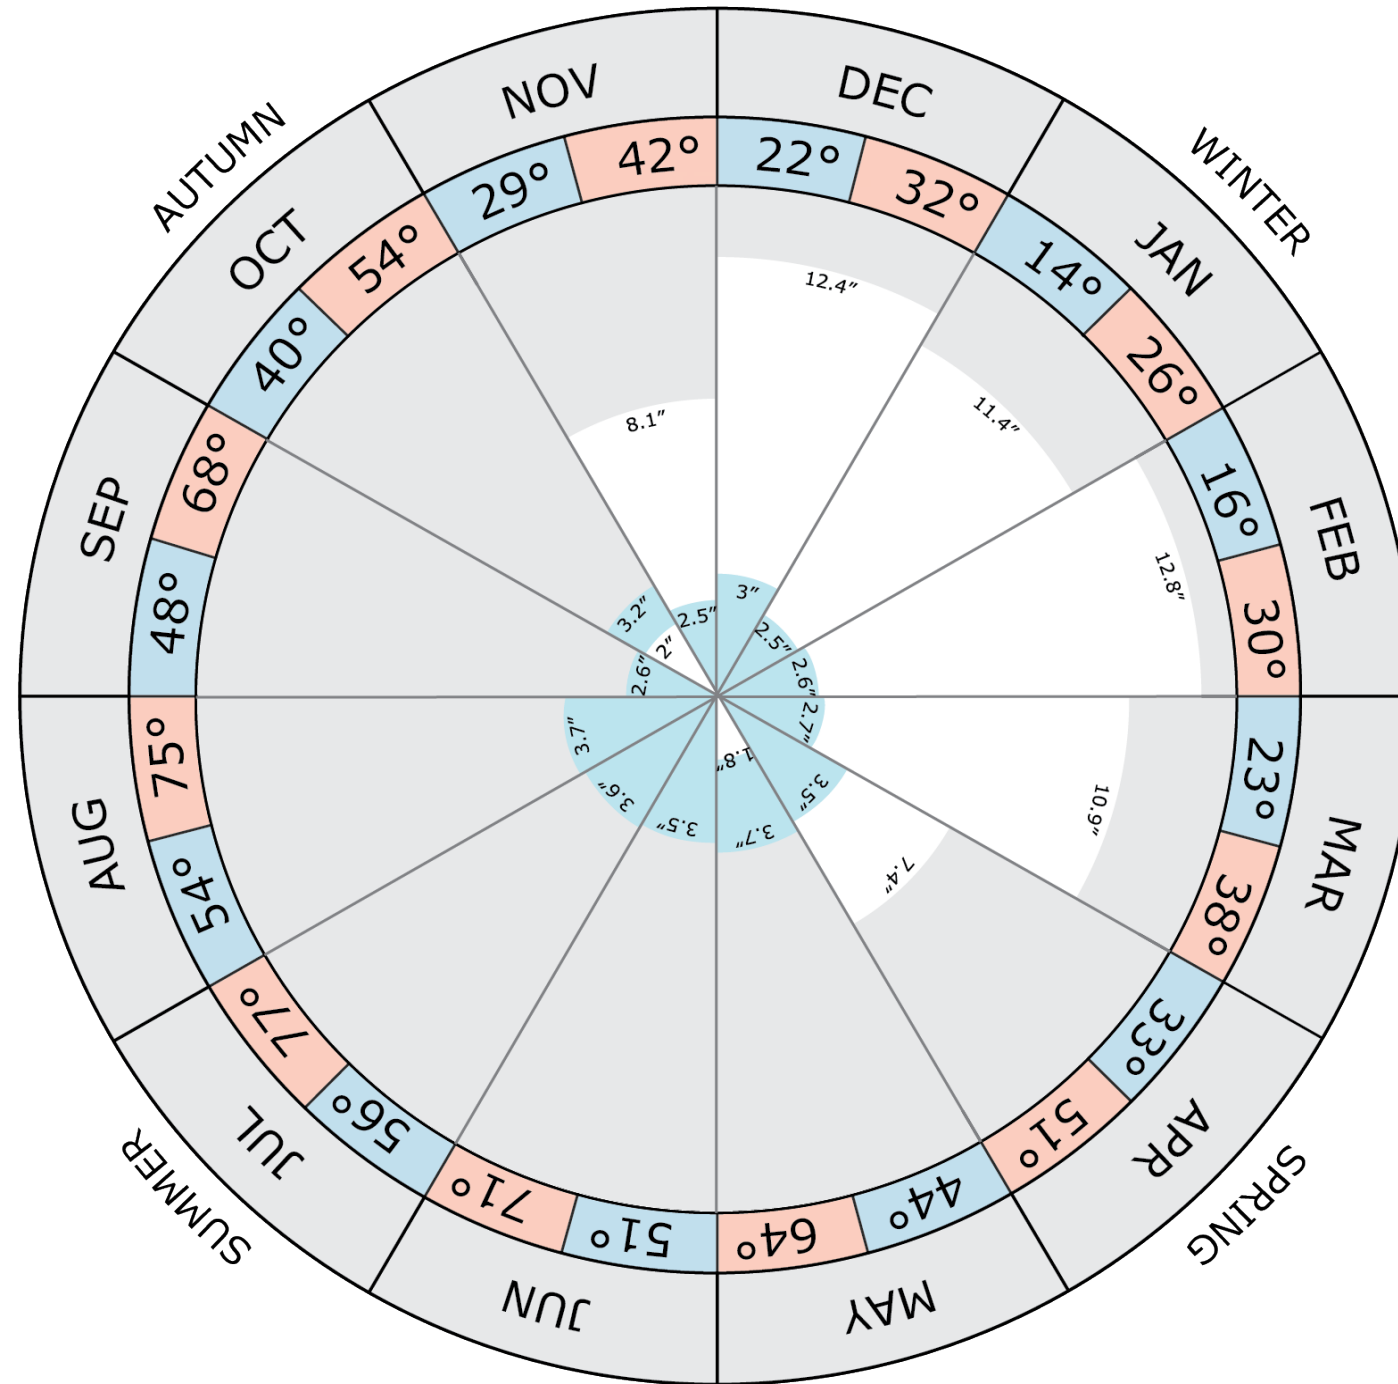
This climate graph shows average high and low temperatures of each month and average rain and snowfall amounts per month in Roxbury.

The warmest month of the year is July

The coldest month of the year is January

April through August sees slightly more rain on average

December through February sees steady snowfall.

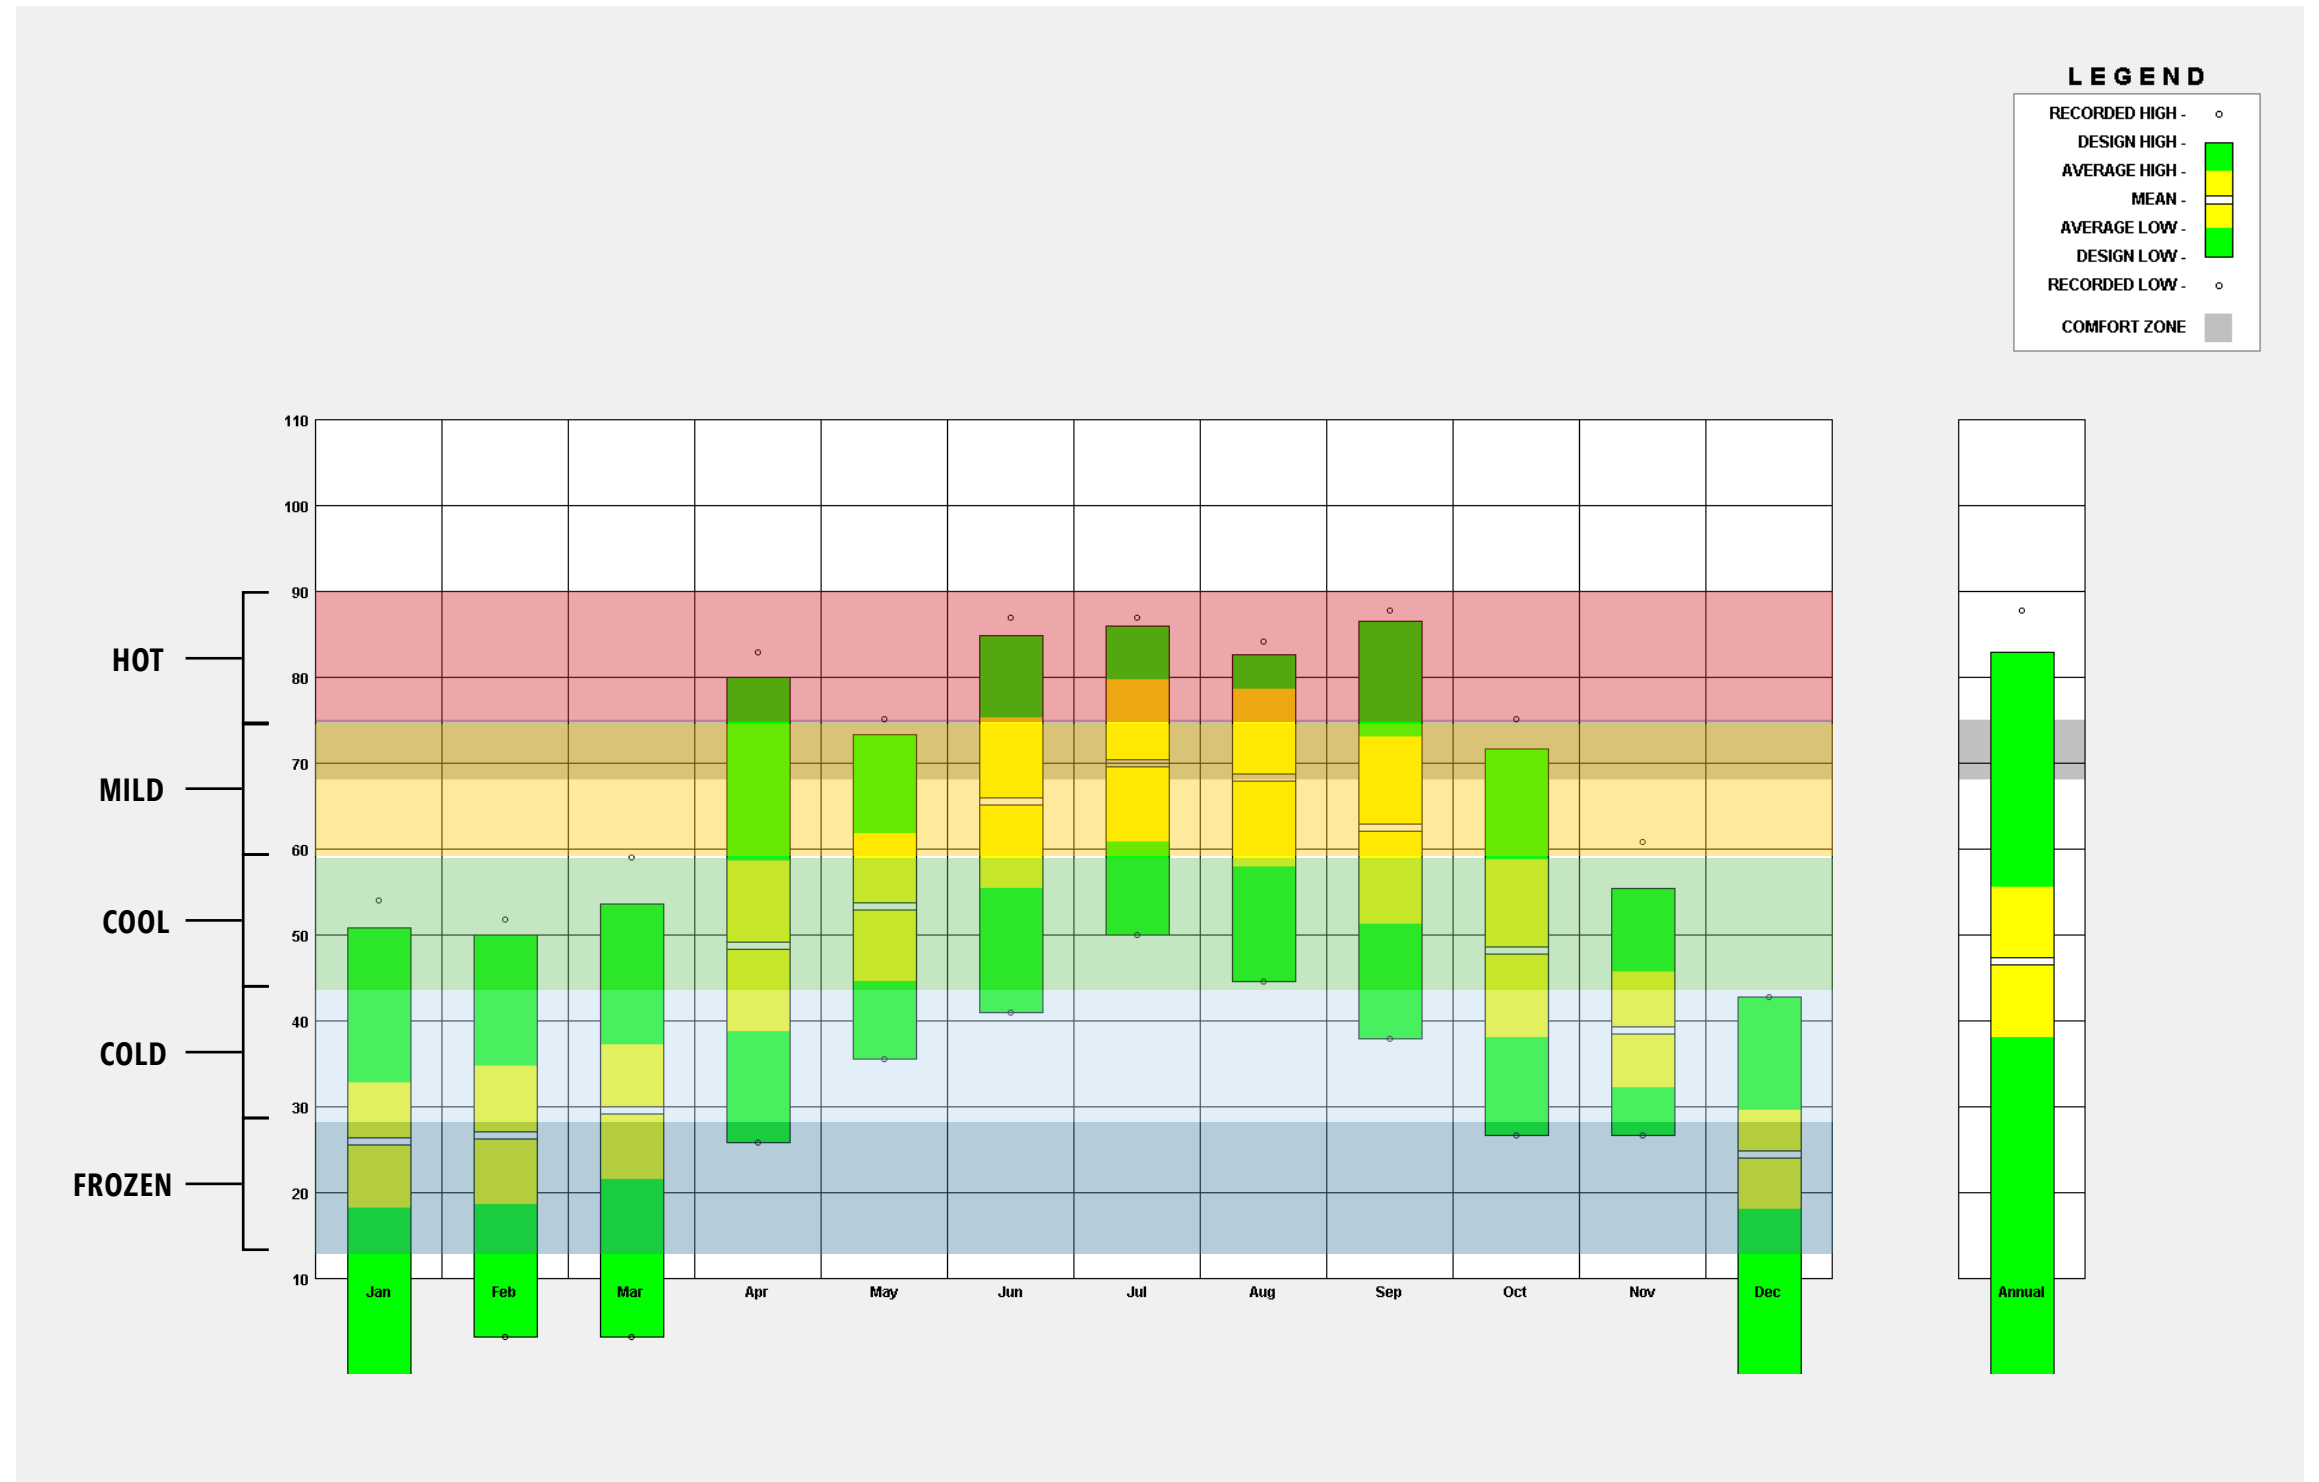
CLIMATE DATA FROM MONTICELLO STATION

SEASONAL TEMPERATURES

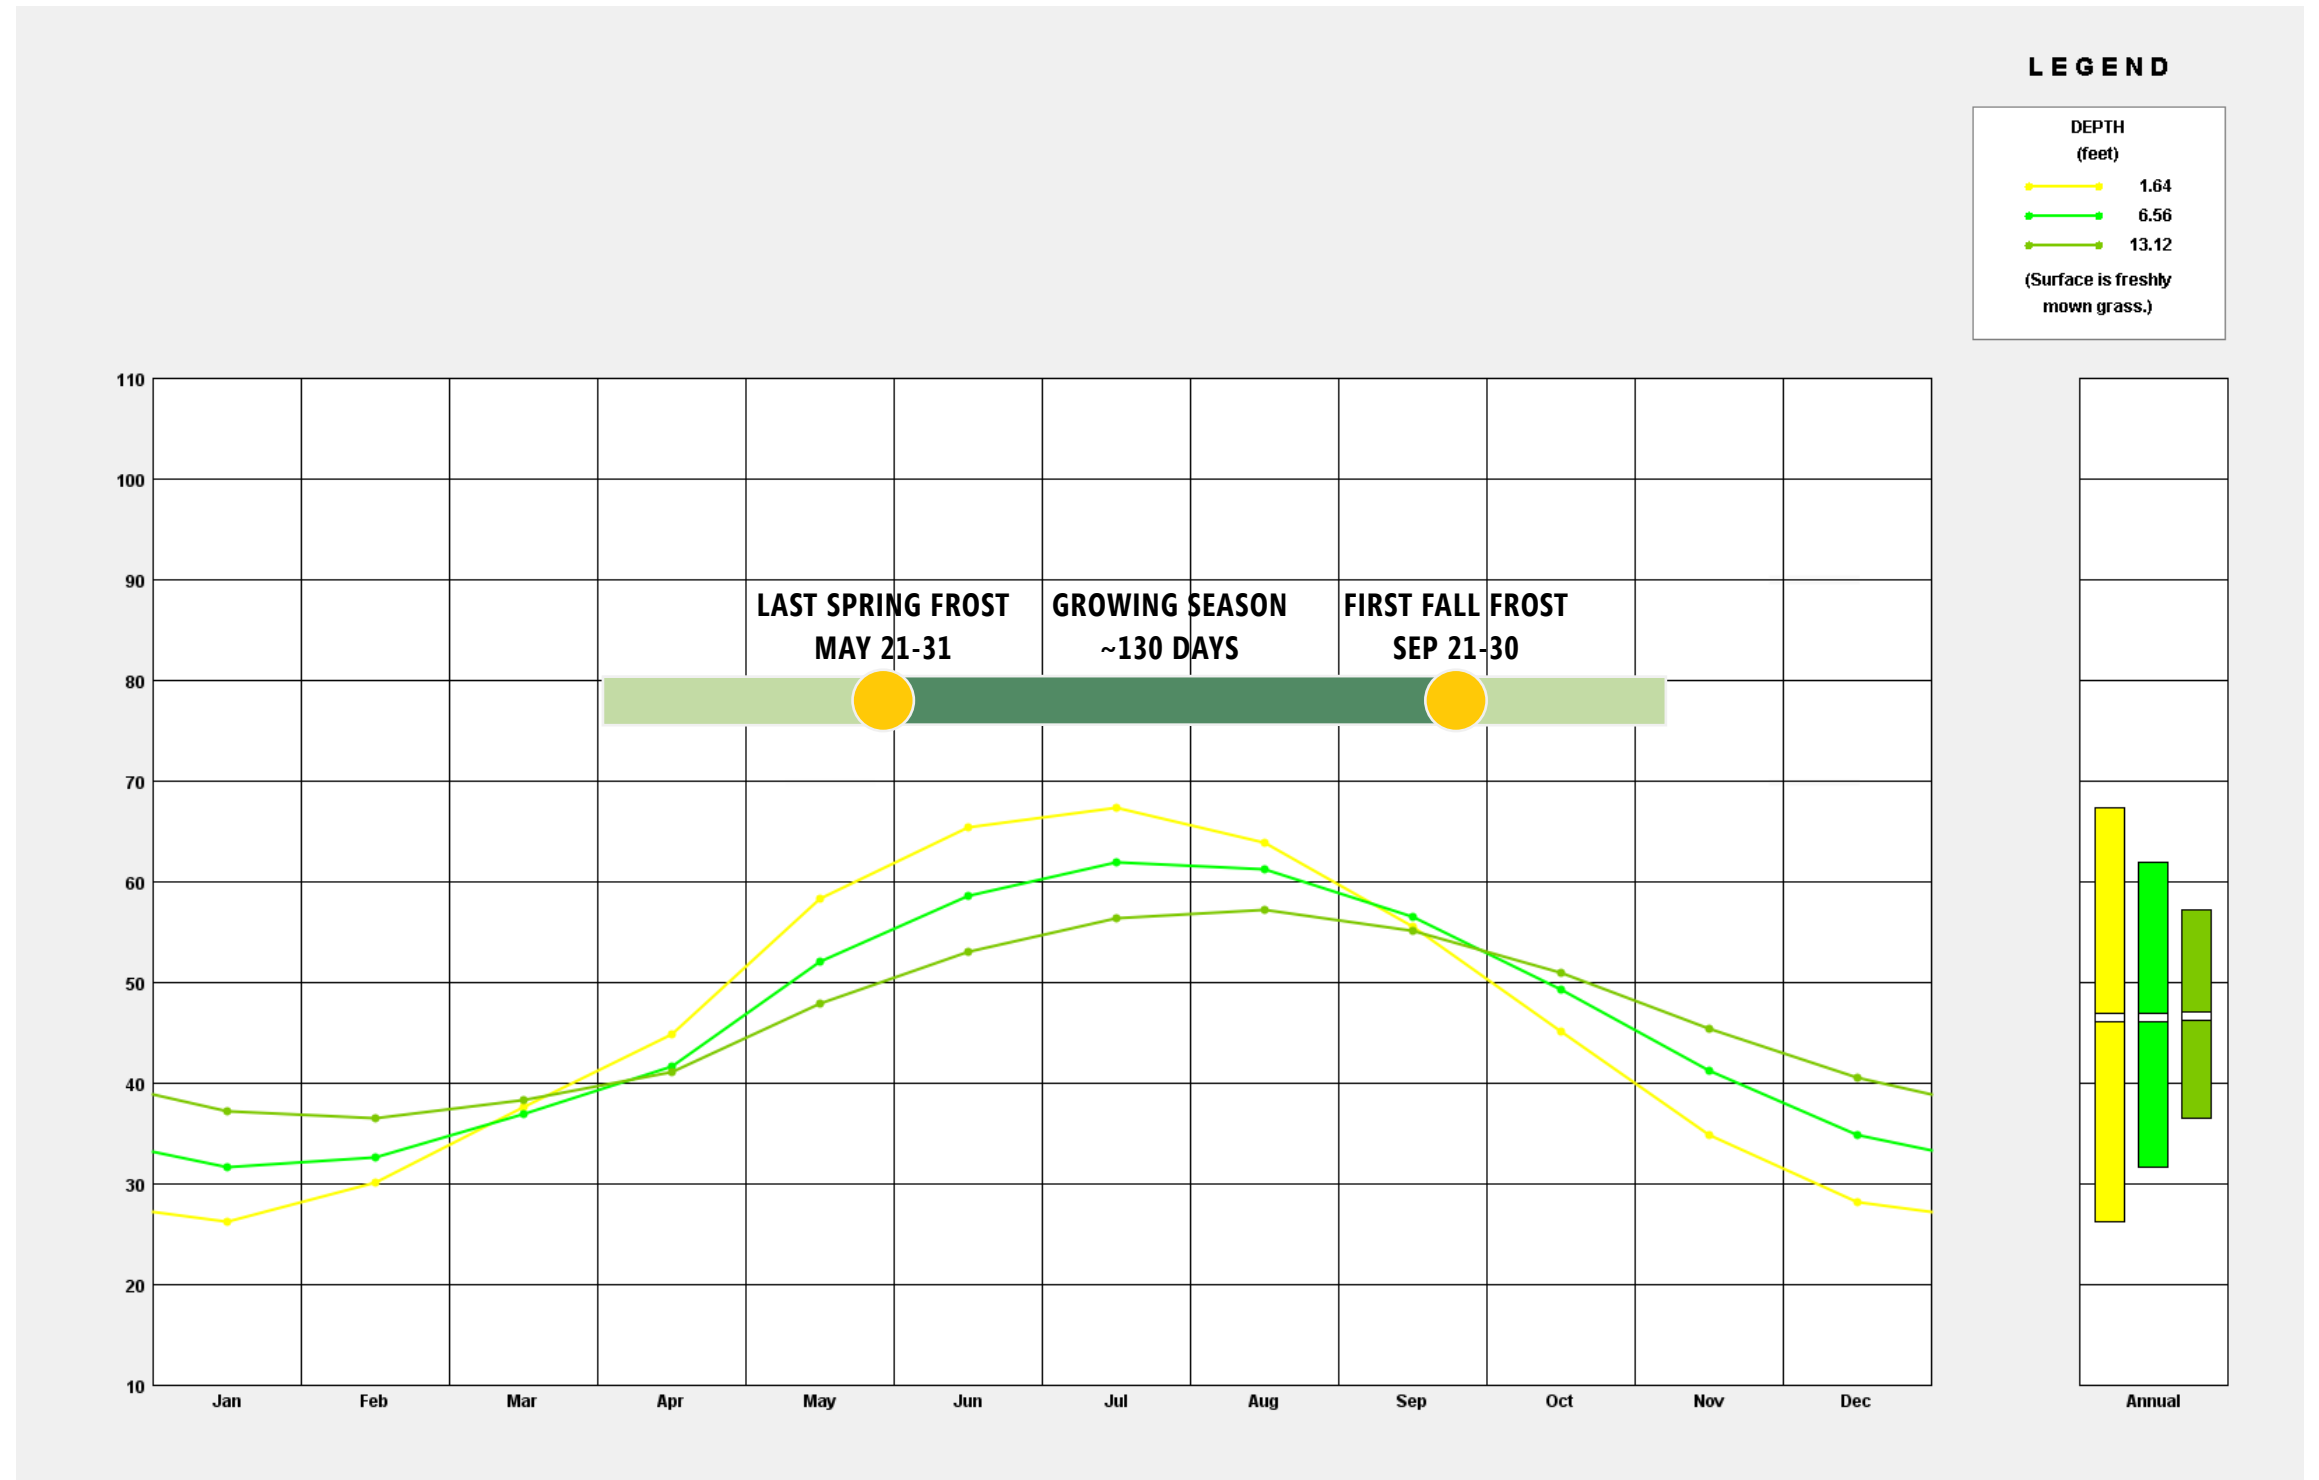
CLIMATE DATA FROM MONTICELLO STATION

GROUND TEMPERATURE

Roxbury is located in a USDA Hardiness Zone 5a, with a few Zone 5b areas on the peaks of surrounding hills.

The average last spring frost falls between May 21st and 31st, and the average first fall frost falls between September 21st and 30th.

Ground can be worked and amended in the spring as soon as the ground temperature is above freezing around late March, and plant into the fall through early November.

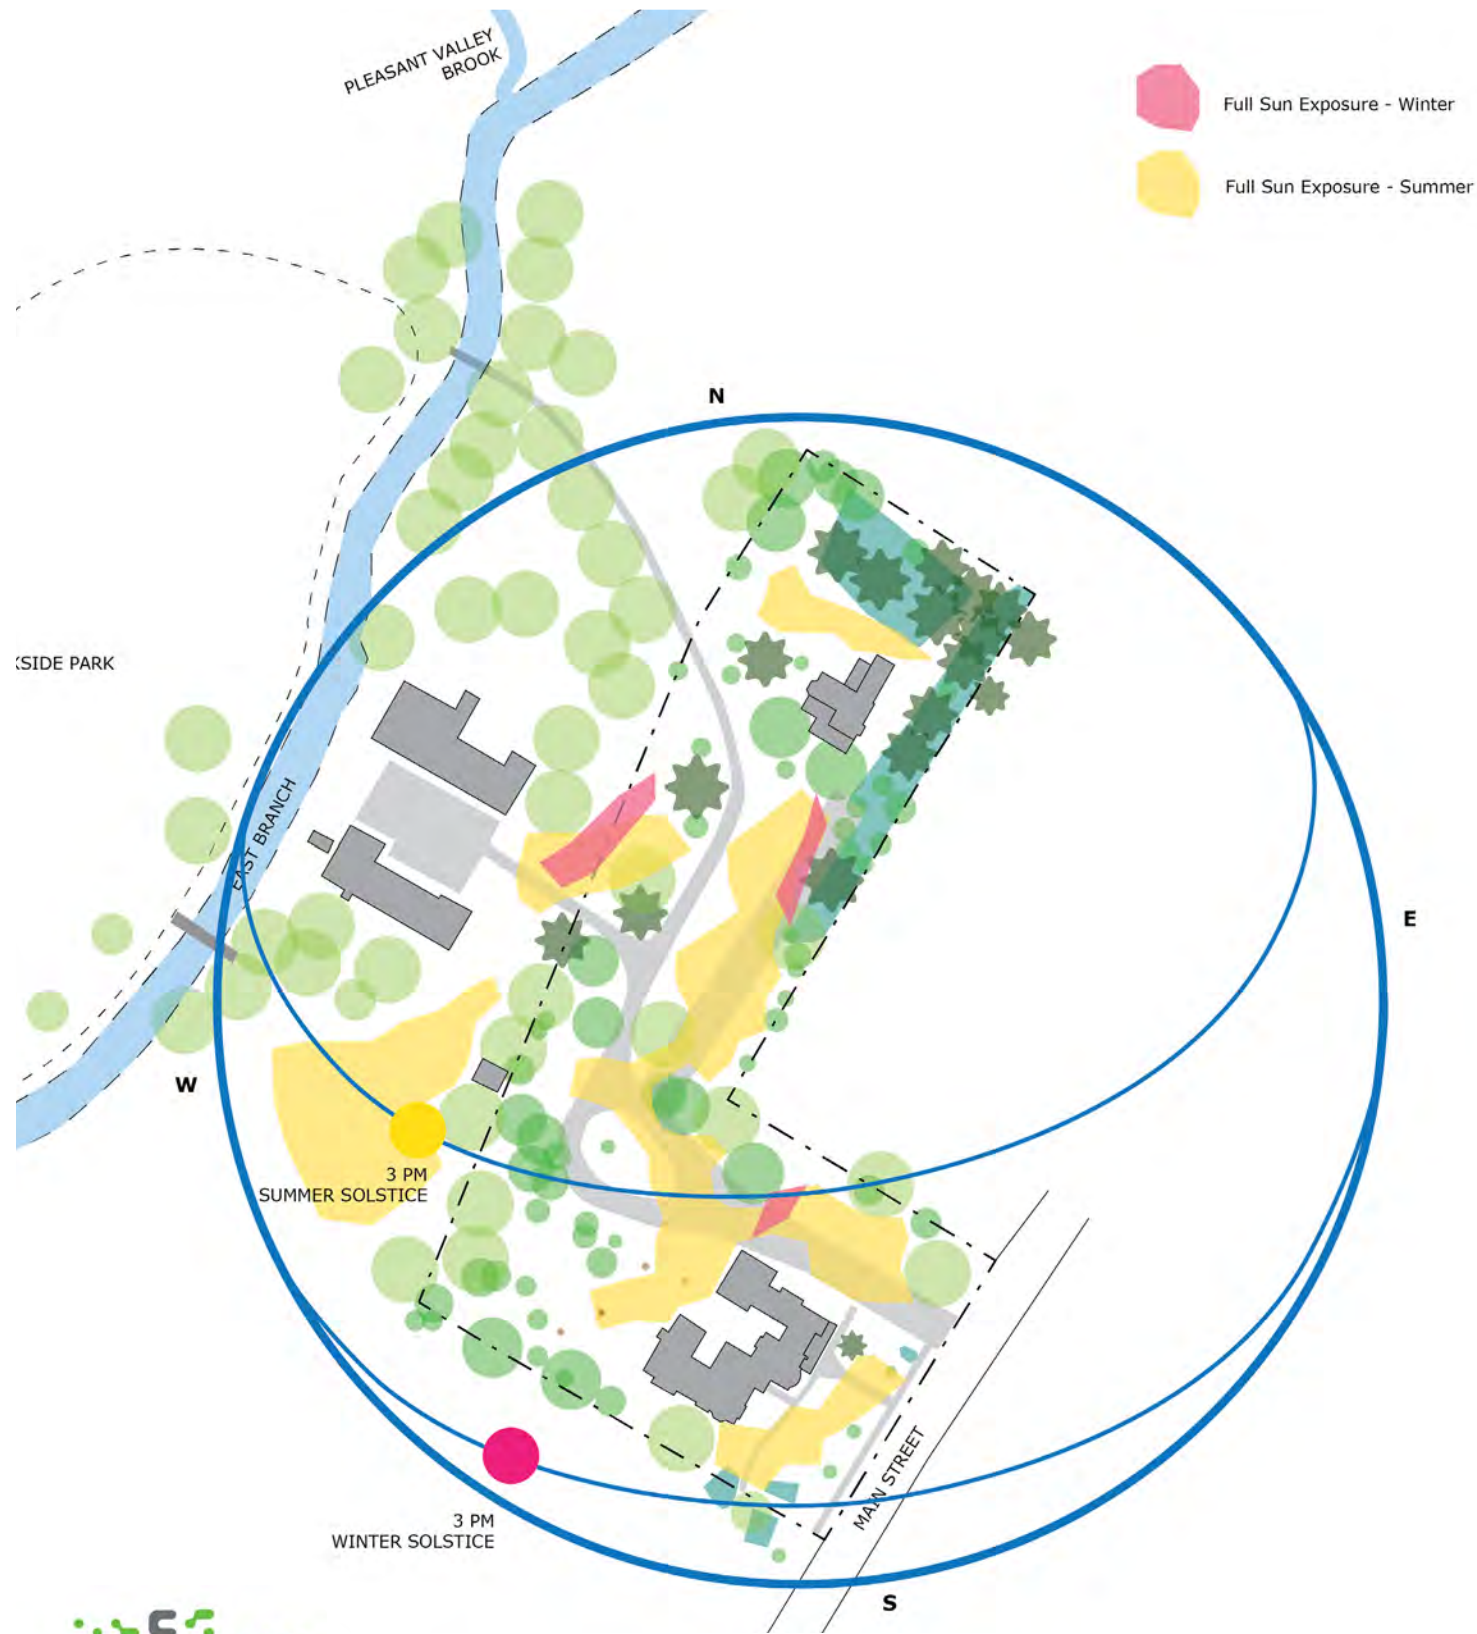
AFTERNOON

Solar Time:	3:00 PM
Day Length:	15:17 Hrs
Sun Azimuth:	257.59
Sun Altitude:	48.43
Hour Angle:	0.01
Declination:	23.43
Sunrise/Sunset:	4:22 am / 7:38 pm
Civil Twilight:	3:47 am / 8:13 pm
Nautical:	3:02 am / 8:58 pm
Astronomical:	2:07 am / 9:53 pm

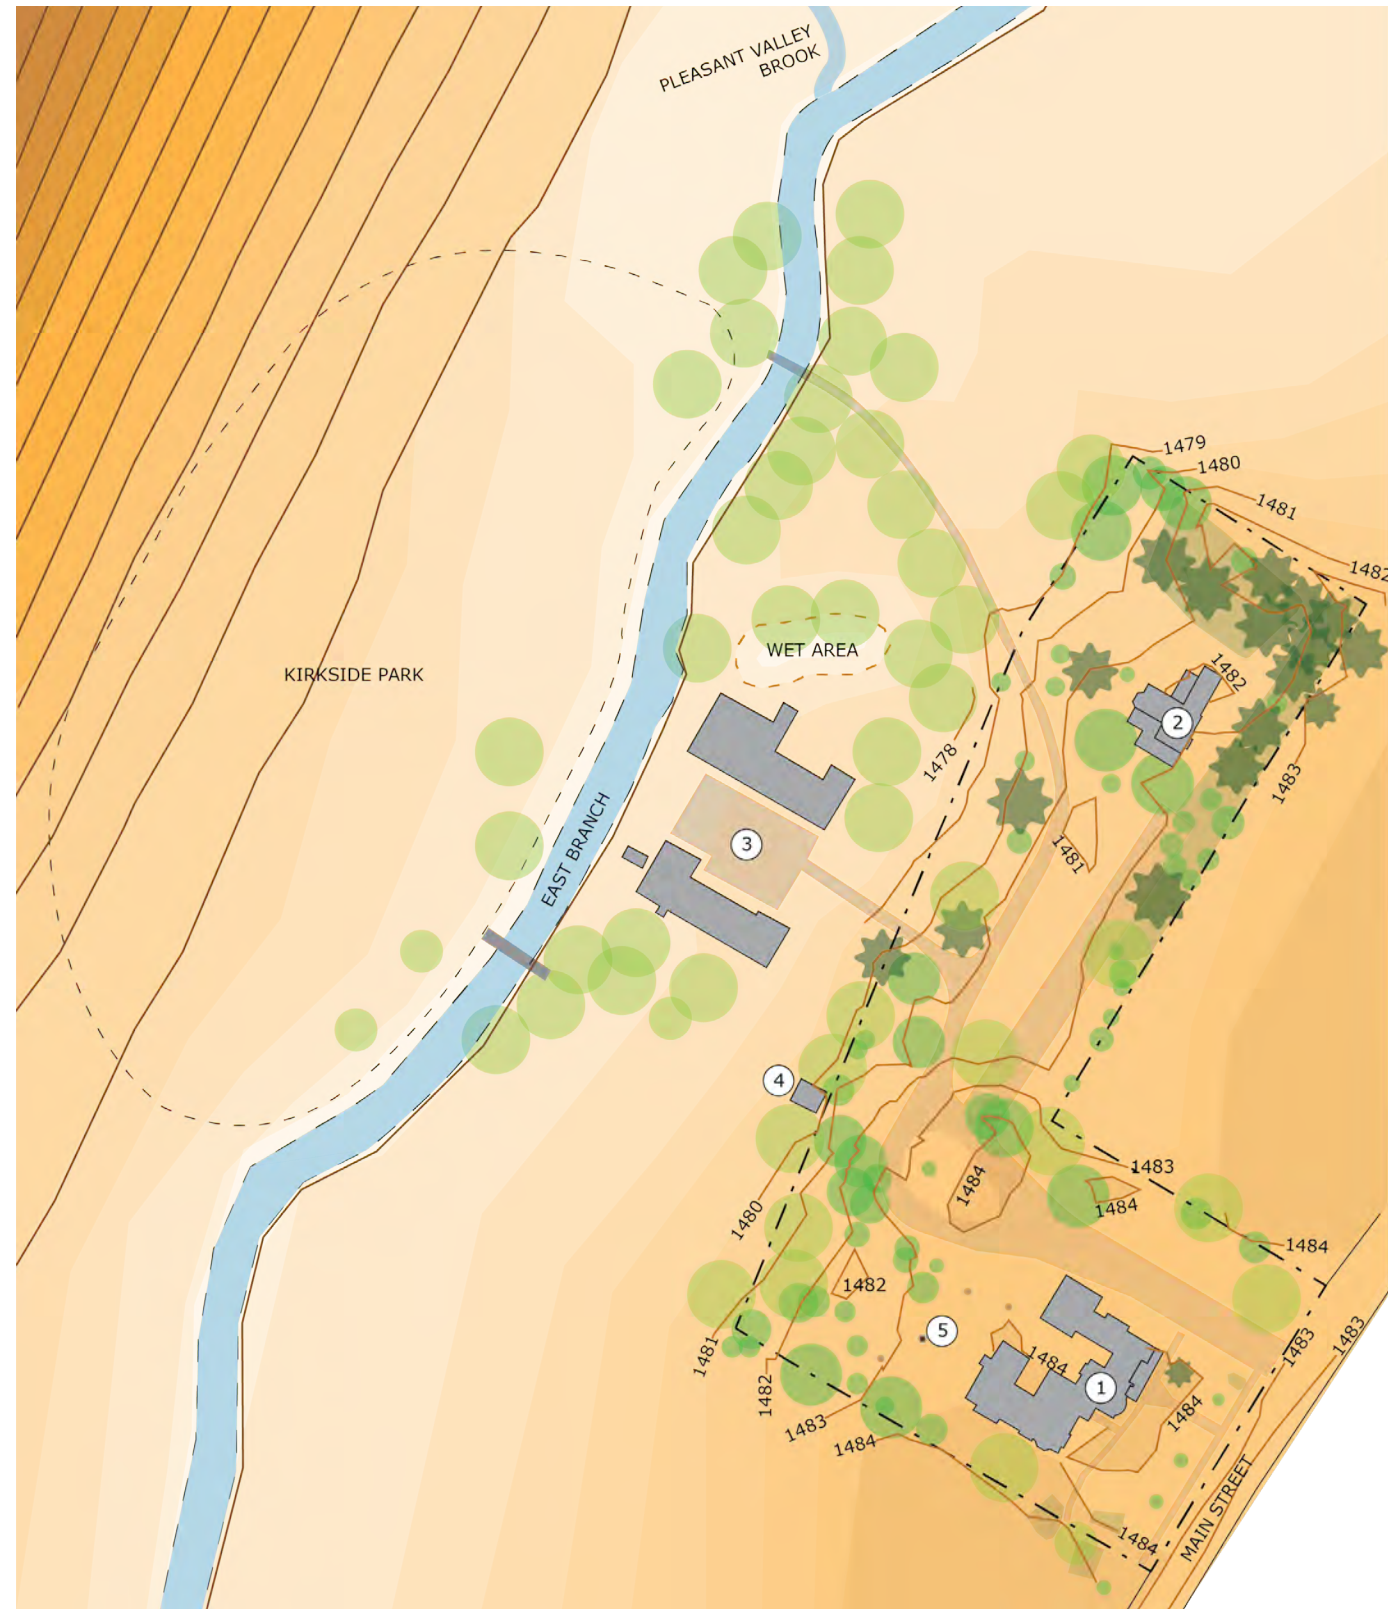
The topography of the site is relatively flat, gently sloping downward from the east towards the East Branch to the west.

Kirkside Park is at the foothill, and is mostly flat with a more pronounced change in elevation as the hill rises up to Sheppard Hill golf course. The low-lying areas of the park are prone to flooding.

There are some areas of high elevation on the Kirkside grounds: in the front yard of Kirkside Mansion and by the existing driveway.

There are also some areas of low elevation on the grounds: southwest of the Summer Cottage and north of the barns. This was marked as a "wet area" in the first survey of the grounds.

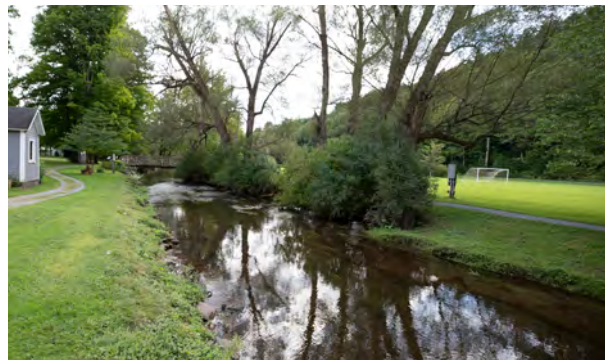
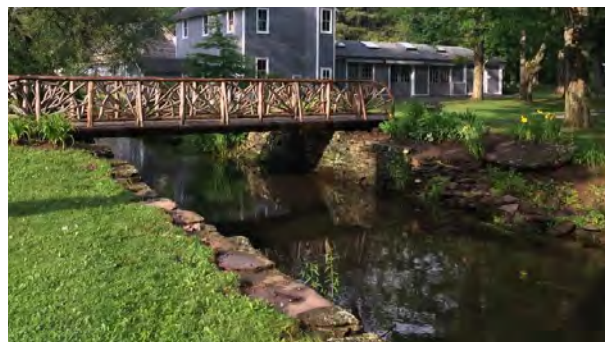
FIGURE 1: DELAWARE RIVER TRIBUTARY MAP

The headwaters of the East Branch begin in a small pond south of Grand Gorge, flowing southwest to create the Pepacton Reservoir, the largest in the NYC drinking water supply, as designated in Figure 1.

East Branch Tributaries are Beaver Kill River and Willowemoc Creek. Contributing mountain-fed streams feed into the East Branch from Vega Mountain, Iris Mountain, Moresville Range, Montgomery Hollow, Pleasant Valley Brook, White Man Mountain, Burroughs Memorial Road, Roxbury Mountain Road, Meeker Hollow, Caroll Hinkley Road, and Cator Roundtop.

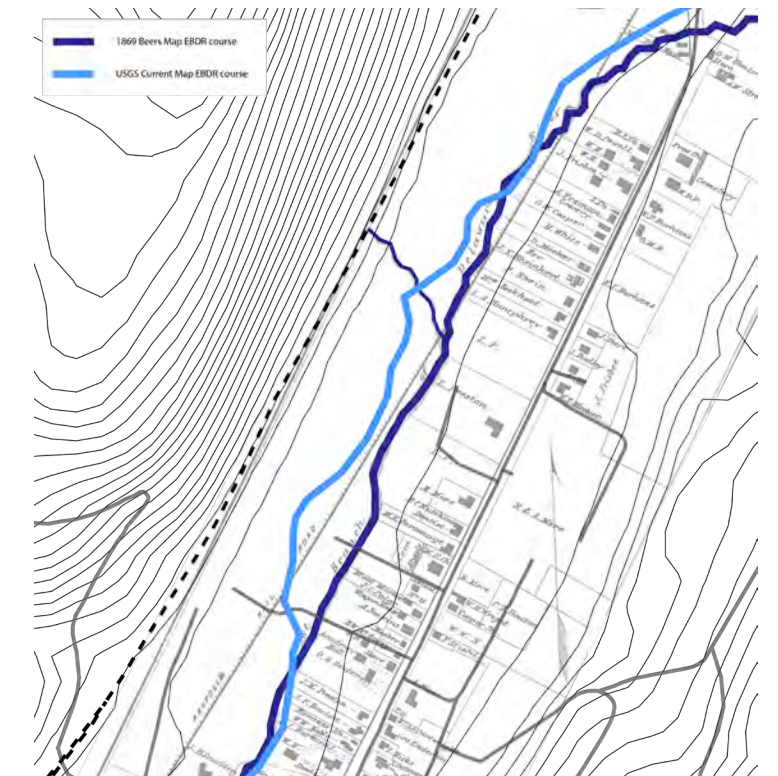
FIGURE 2: MOVEMENT OF THE EAST BRANCH

Figure 2 is a topographic map of the current course of the East Branch overlaid on the 1869 Beers map of Roxbury, showing the change in the river's course. This section of the river has been moved to accommodate the placement of the railroad and development in the flood plain (2020 Local Flood Analysis).

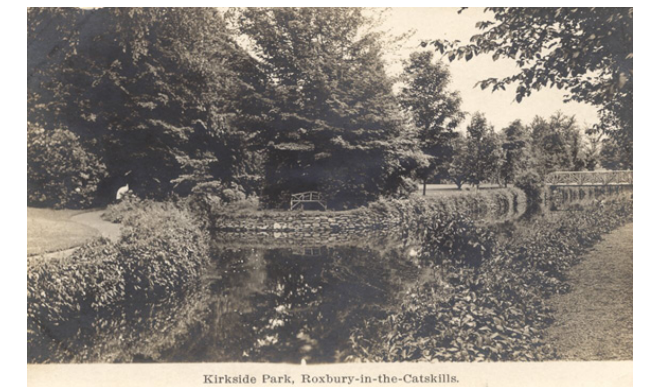
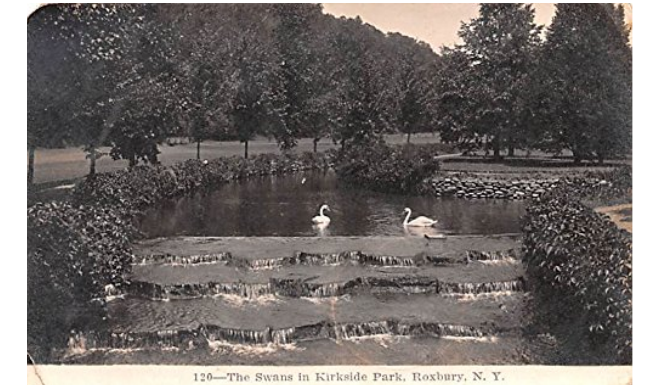
The development of 12-acre Kirkside Park in 1910-1915 formalized the river course with stone retaining walls, an island in the river, rustic bridges, pathways, and landscaped garden beds (Living Places).
