KIRKSIDE INN

SITE RESOURCES ANALYSIS

The purpose of this Site Resources Analysis is to compile a holistic understanding of existing conditions of the environment encompassing Kirkside Inn to inform the design team’s schematic layout and program. Evaluating the physical environmental conditions before finalizing the site design will enable the most contextually appropriate schemes to present themselves, as well as represent the Earth as a project stakeholder as we become aware of potential short- and long-term implications of new activity on the site.

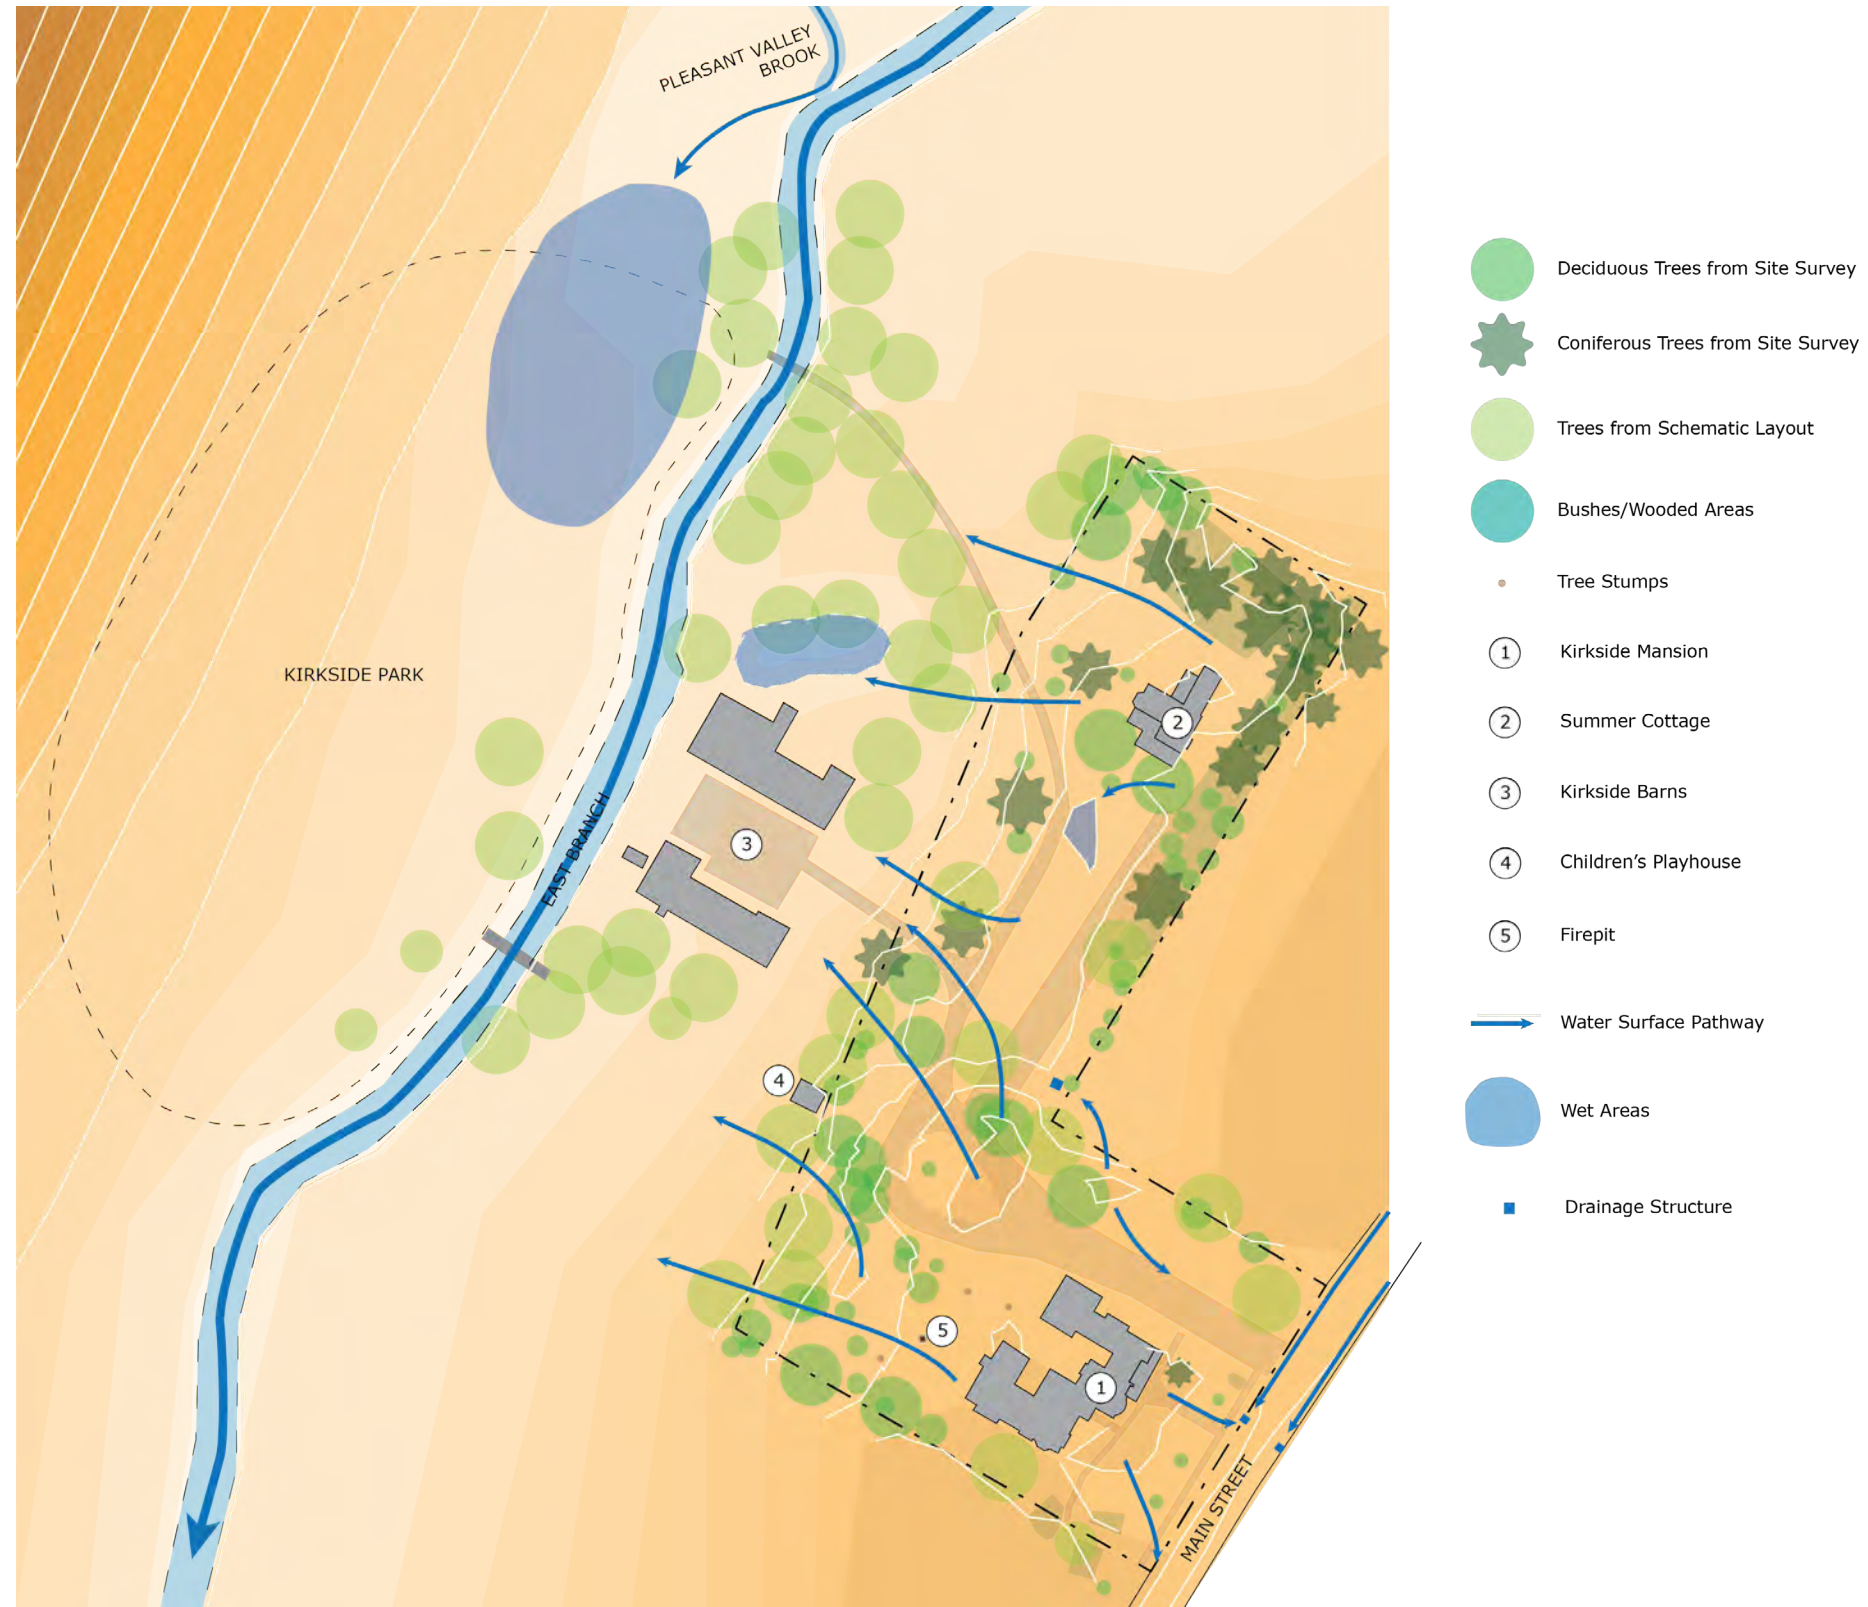
WATER MOVEMENT

- The 2020 Local Flood Analysis studied the perennial wet area in Kirkside Park, which is caused by the confluence of Pleasant Valley Brook and the East Branch.
- Water moves across the site from high elevation to low elevation, generally across the contours and west towards the river. The blue arrows in the diagram indicate potential surface water runoff pathways.

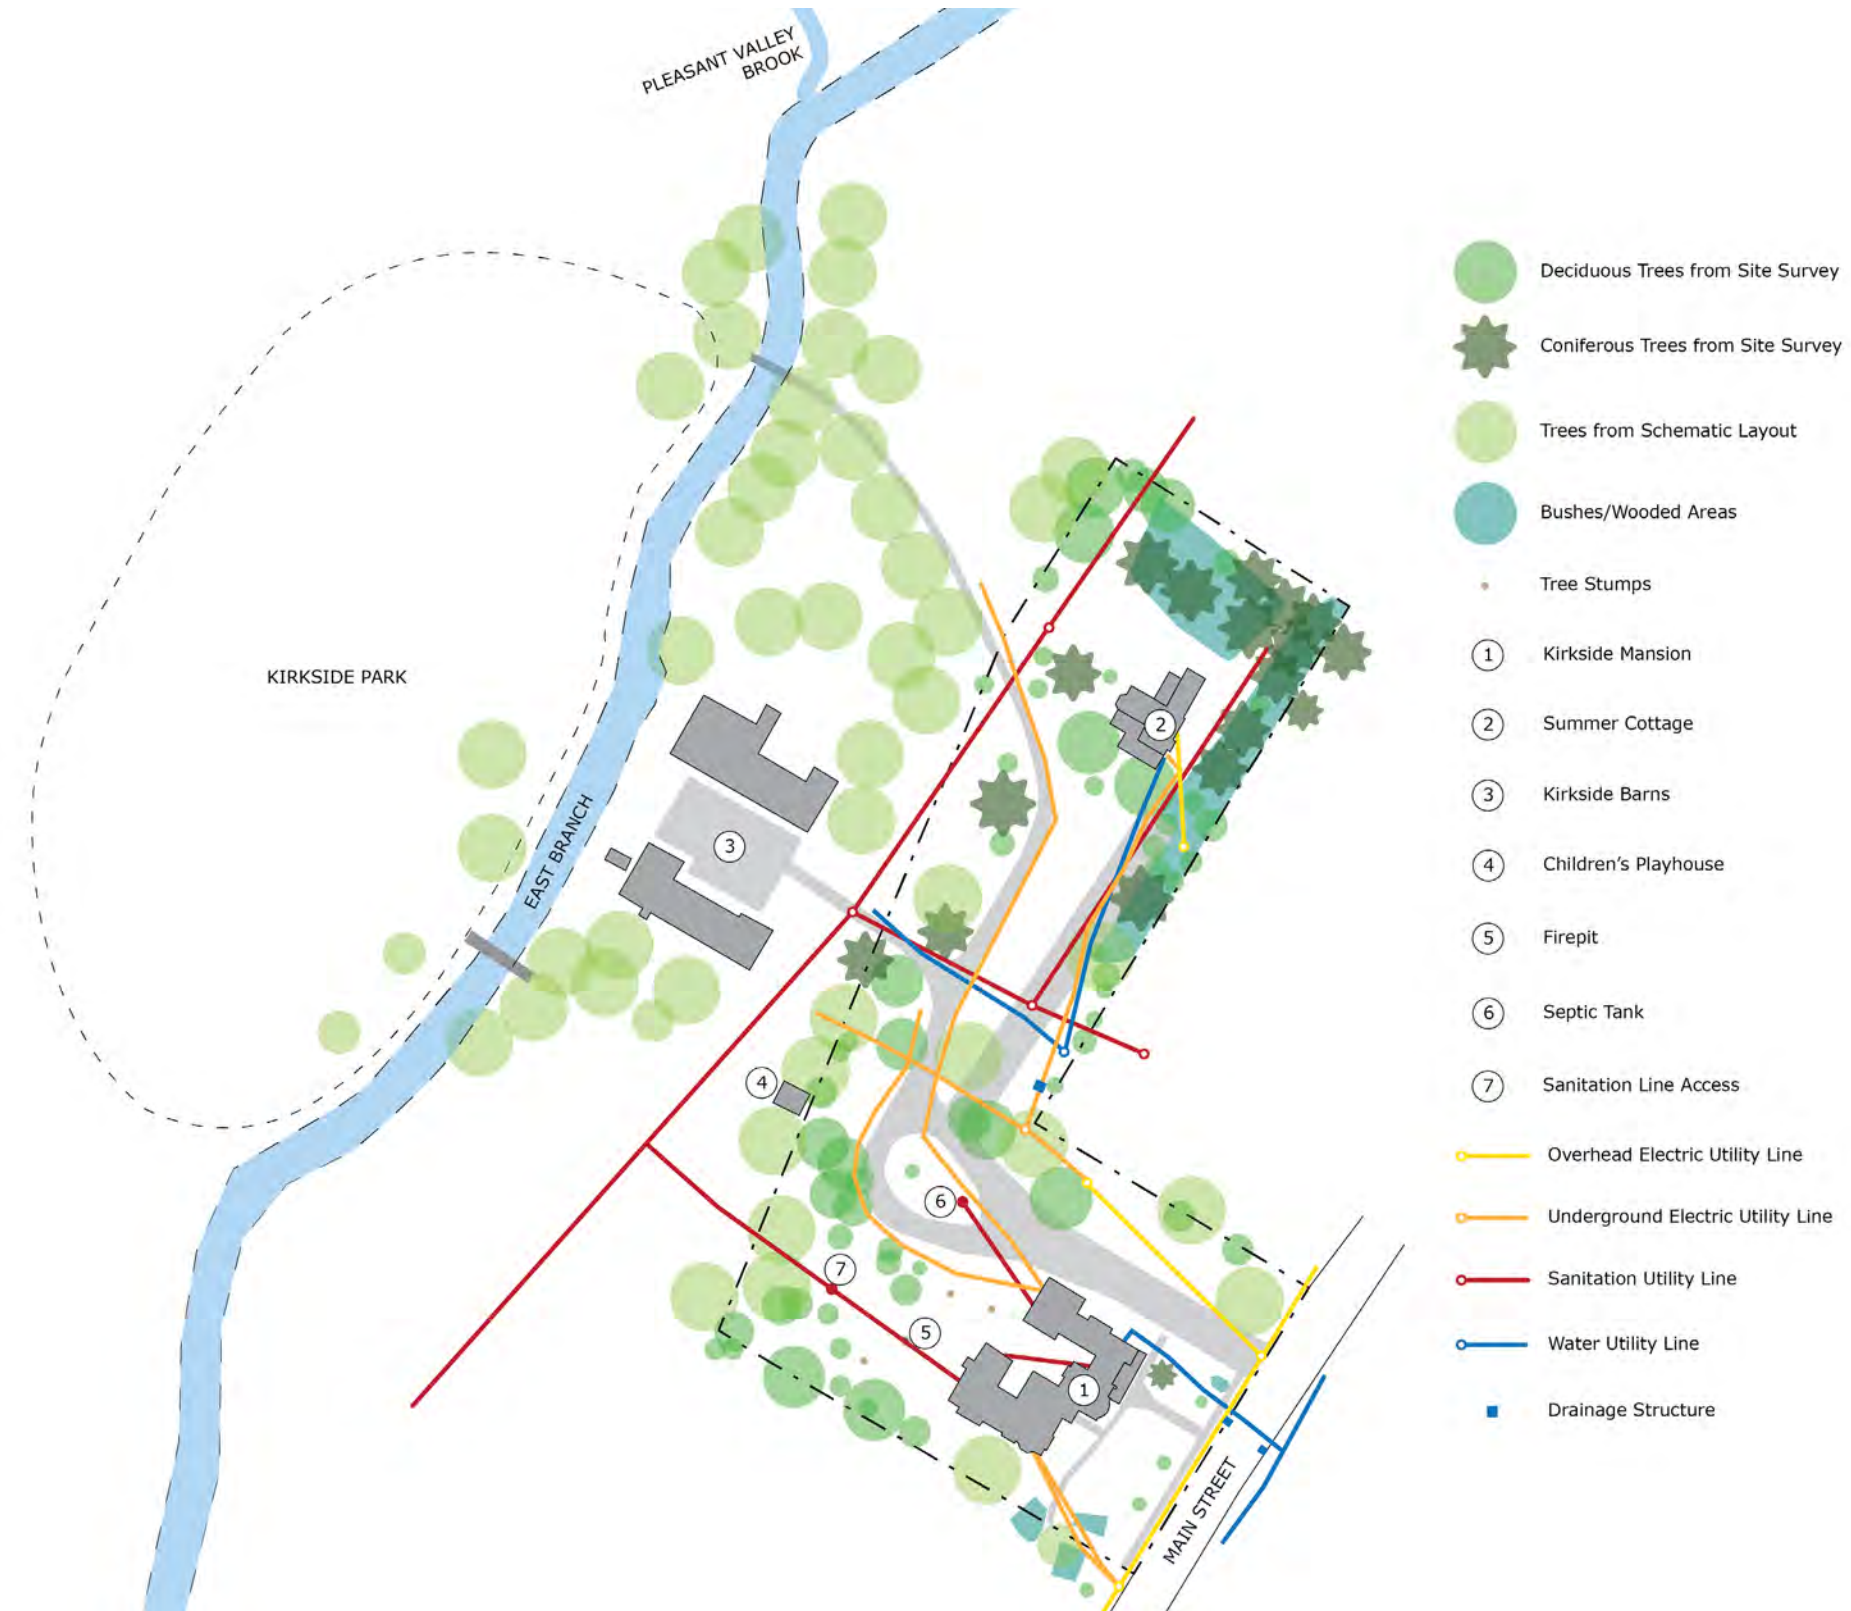
EXISTING UTILITIES

- Existing utilities mostly run underground with the exception of some overhead electric lines connecting to Main Street
- Further investigation of the utility connections to the barns is needed
- The survey did not show a sanitation connection to the Summer Cottage
- The quality and capacity of the existing septic tank should be evaluated

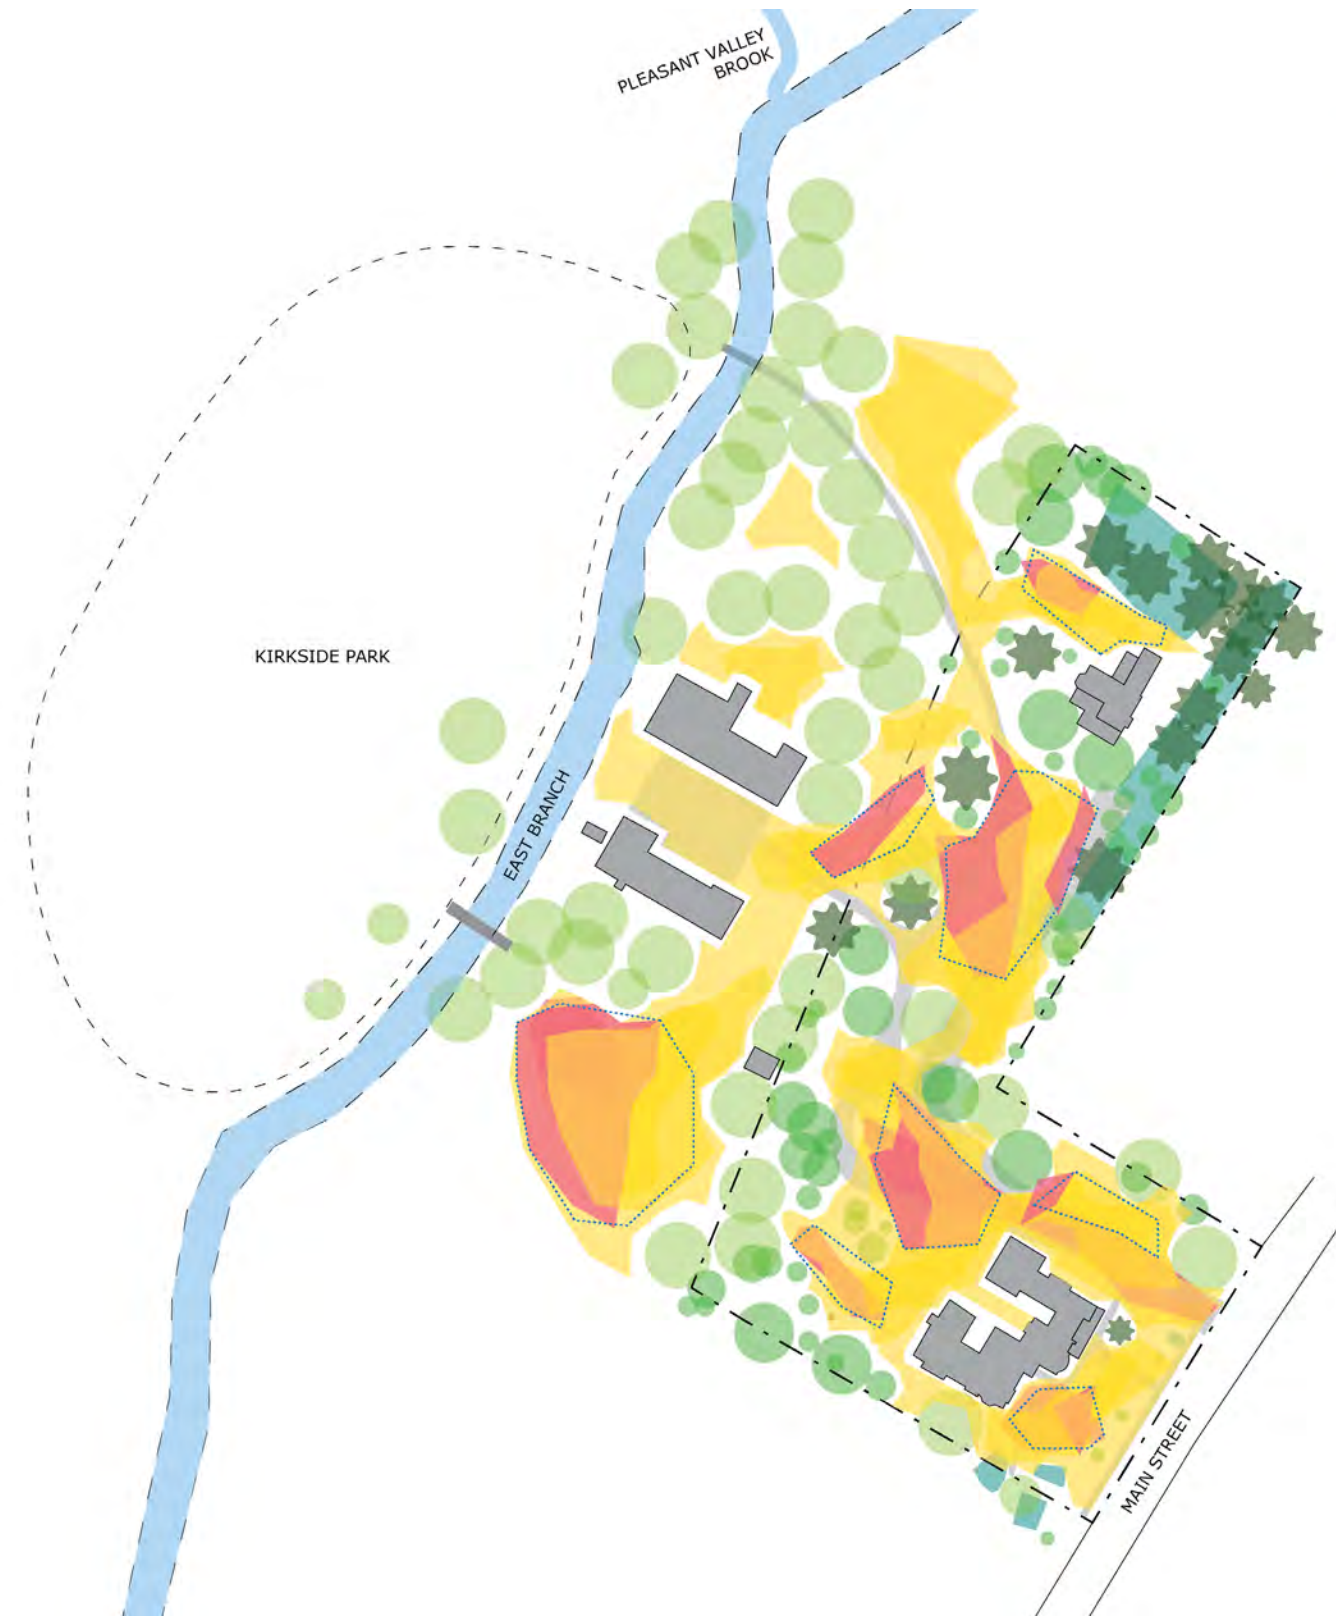
FULL SUN EXPOSURE

The location of sunlight on the site is important for planning site elements such like gardens and planting areas. Agricultural production, such as raised beds or a greenhouse, should be located in an area with full sun exposure year-round to be most productive.

Areas without full sun exposure can still be planted with varieties that tolerate partial or full shade, and can also be used to site contemplative public realm elements, such as hammocks and seating areas.

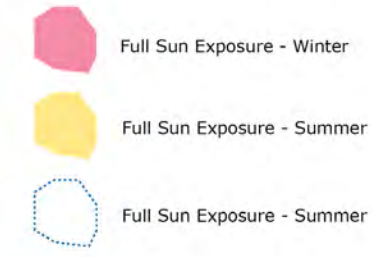
SUNSHINE HOURS

Jan	3.1 hours
Feb	2.9 hours
Mar	4.6 hours
Apr	6.7 hours
May	7.8 hours
Jun	8.7 hours
Jul	9.8 hours
Aug	9.2 hours
Sep	8 hours
Oct	4.6 hours
Nov	4.3 hours
Dec	3 hours
